WWS Case Study

Project: WA Maritime Museum August 2009

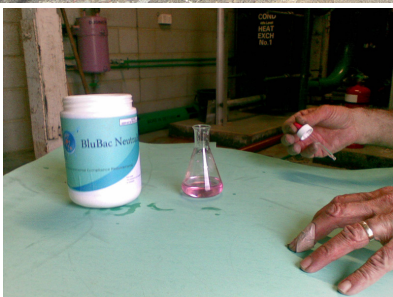
Neutraliser test kit

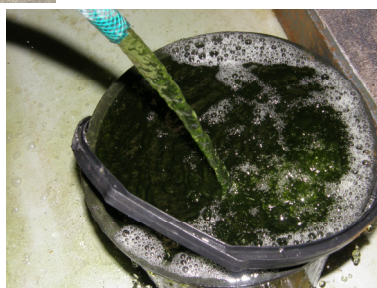
Neutralised water

Neutralised water tested at pH 7.09
